**The Current Picture -
Open Space Audit
Results**

2.0 The Open Space Audit was a comprehensive study of a total of 397 publicly accessible open spaces in South Staffordshire conducted in accordance with PPG17 guidelines. Outdoor sports facilities were audited separately by Hall Aitken, the results of which are contained in the Playing Pitch Strategy. The site survey and consultation results were analysed and a series of standards set for each typology. These standards were then applied and a number of practical recommendations made for the improvement of these sites. These recommendations have provided the basis for policies in the LDF Core strategy relating to open space.

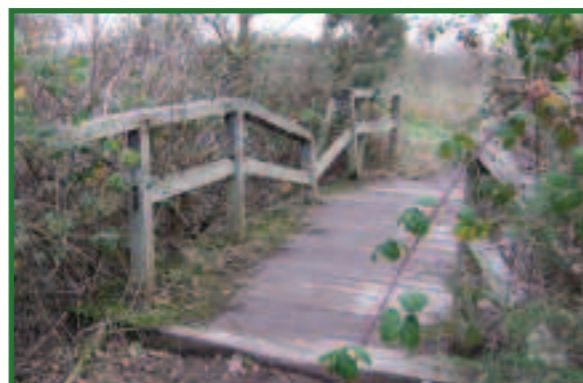
- **Graffiti** was identified at 5 of the 27 sites (19%), and **littering** was identified as an issue at 6 sites (22%) particularly those along the

Wyrley Essington Canal (this is the Council's common name for the site, the correct name of which is the Wyrley Bank Branch).

- It is suggested that in areas along canals where environmental quality is poor **environmental improvements** would be beneficial.

Improvements could include improved access to towpaths, **links to existing footpath networks and open spaces**. Areas of particular concern are cross-local authority boundary areas.

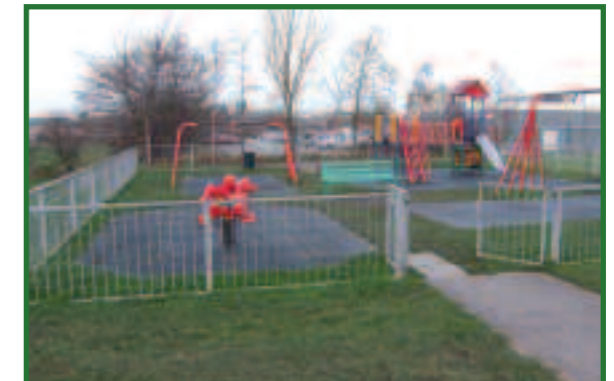
Quinton Park, Great Wyrley

- Some of the sites, including **Quinton Park** (Great Wyrley) and several other more secluded sites, were highlighted as being targets of occasional **anti-social behaviour**, which discourages other children from visiting the sites. Suggestions raised during the consultation include park wardens (particularly for the larger sites) or installing CCTV cameras. 3 sites were highlighted as being particularly **secluded** and it was suggested that there may be a safety issue for children using these sites unsupervised.

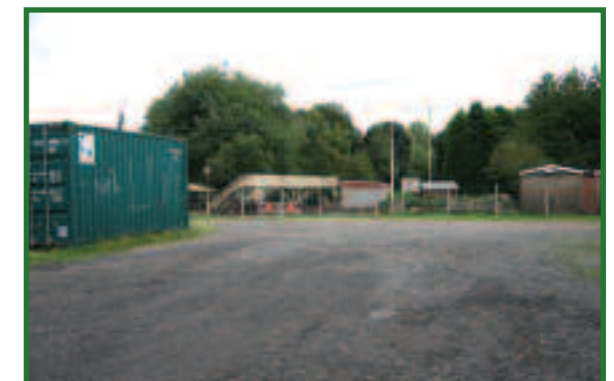
Marsh Playing Fields Playground, Kinver

- The most successful sites, including **Marsh Playing Fields Playground** (Kinver) and **Heron Drive Play Area** (Penkridge), were found to be those, which are obviously **regularly maintained and monitored**, especially in terms of clearing litter and repairing broken /vandalised equipment. These sites are also **securely fenced and gated** with **appropriate**

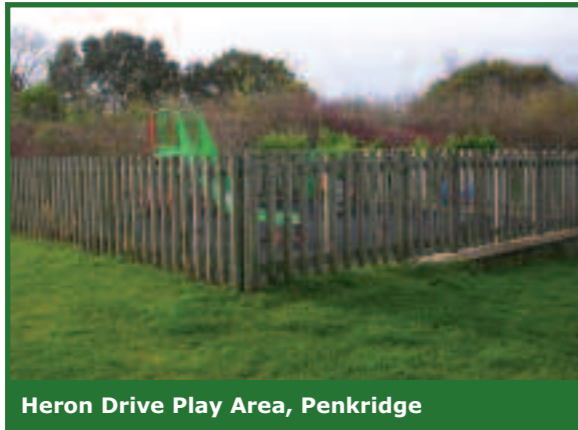
Heron Drive Play Area, Penkridge

signage. Ensuring that a child can use a play facility safely is the most important factor when assessing a site's success.

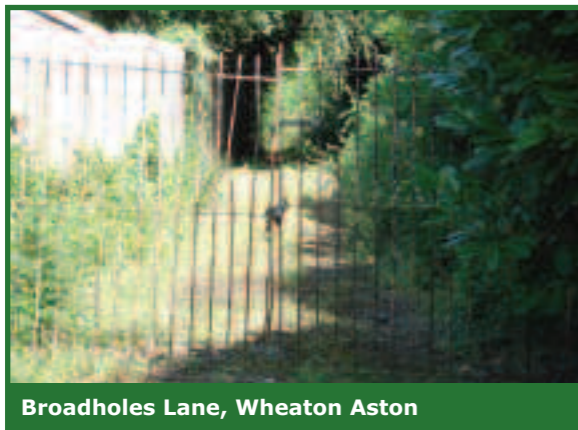
Broadholes Lane, Wheaton Aston

- The play area at **Broadholes Lane** (Wheaton Aston), which is currently closed should either be renovated and re-opened as a formal play area or used for another purpose, such as allotments.

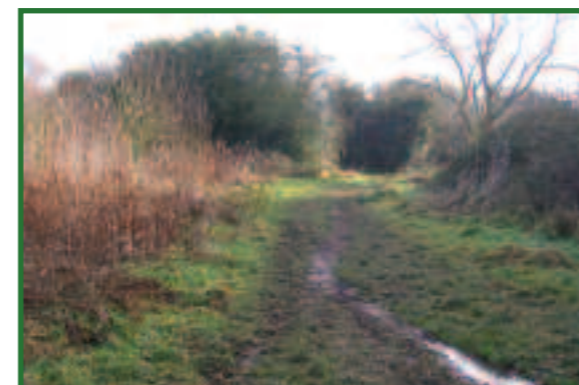
Dippons Lane, Perton

- Several of the sites, including the field off **Dippons Lane** (Perton), lack any form of signage altogether, which combined with a lack of formal access routes (e.g. established gateways), made it difficult to identify whether the sites were publicly accessible. This may deter some members of the public from using these sites or encourage inappropriate use of sites that do not appear to be formally designated.

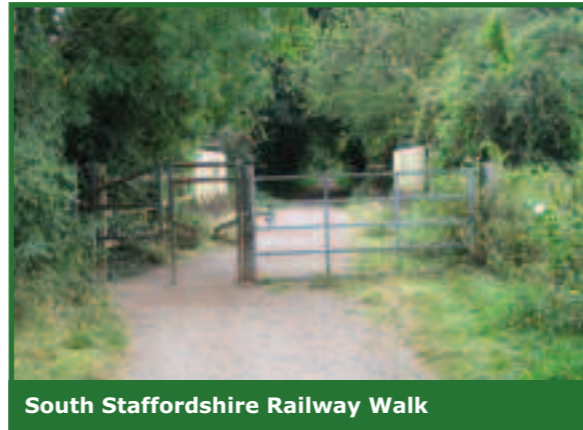
South Staffordshire Railway Walk

- A major issue in terms of accessibility was a lack of adequate disabled access, whether through **inappropriate footpath surfaces** or **unsuitable entryways**. The **South Staffordshire Railway Walk** for example is only accessible at certain points via steep steps, which would be unsuitable for wheelchair users. **Narrow or locked gateways**, at some access points on the Staffordshire and Worcestershire Canal towpath, also preclude wheelchair access. Inadequate disabled access was identified as a problem at 11 of the 27 sites (41%). However, it is recognised that the historic nature of these

sites makes provision of full disabled access impracticable in certain cases.

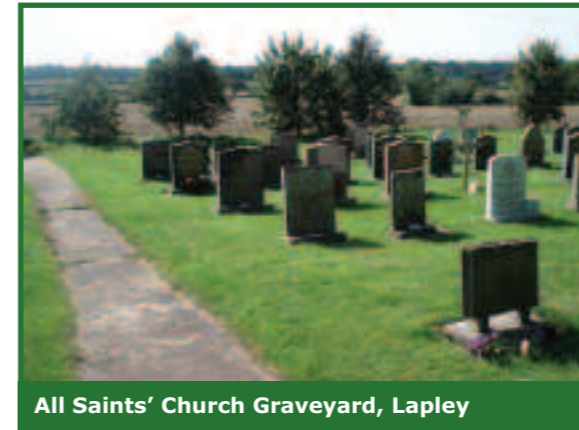
All Saints' Church Graveyard, Lapley

- Two of the sites (**All Saints' Church Graveyard, Lapley**, and **St. Leonard's Church, Dunston**) were identified as having **inadequate signage**. For visitor information purposes it would be beneficial to have a sign identifying the name of the church at its entrance.

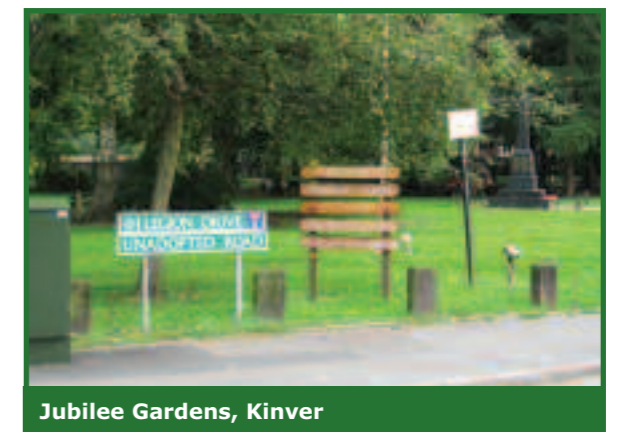
Jubilee Gardens, Kinver

- The most successful civic spaces, such as **Jubilee Gardens** (Kinver), are **well maintained, easily accessible, well lit** and have suitable provision of **benches and litter bins**, enabling people to experience optimum enjoyment of the spaces.

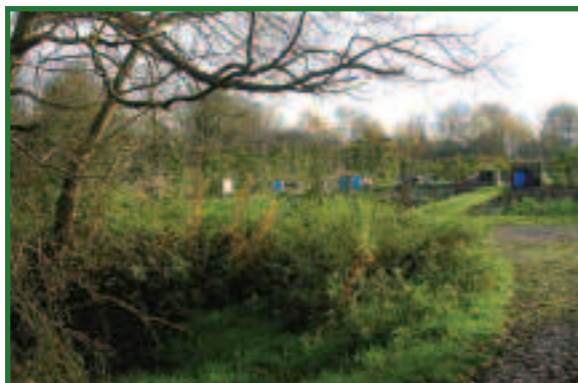
Wolgarston Way Allotments, Penkridge

- All sites were found to be **generally well maintained**, with littering often only a minor issue along some site boundaries.
- 4 of the 9 sites (44%), including **Pinfold Lane Allotments** (Cheslyn Hay) and **Wolgarston Way Allotments** (Penkridge), **lacked appropriate signage**, in terms of identifying the site itself, providing contact details, and for enquiries about renting an allotment. This is important for

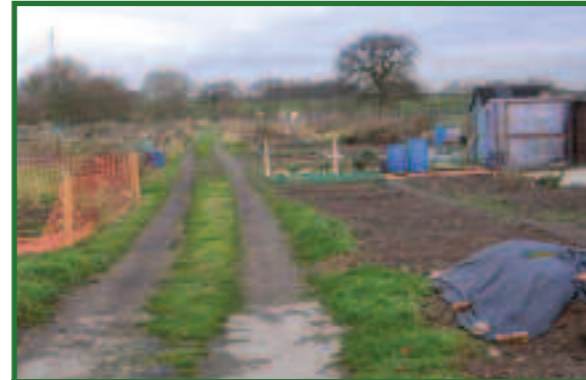
Pendeford Mill Lane Allotments, Bilbrook

- Disabled access was not found to be an issue in the majority of cases, although there were a couple of sites (**Chambley Green, Coven** and **Pendeford Mill Lane allotments, Bilbrook**) in which access by wheelchair would have been difficult, due to **uneven pathways and entryways**. The entrance gates to several of the allotments were large and heavy and may prove difficult for wheelchair users to open.
- The most successful sites, including Francis Green Lane allotments in Penkridge, were those that demonstrated appropriate surfaces for wheelchair users, securely padlocked gates accessible by permit holders only, and suitable signage at the site entrance.

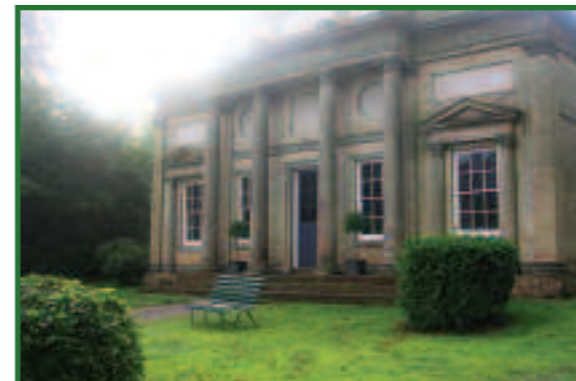
Chillington Hall, Brewood

- Several of the historic parks and gardens, including **Weston Park, Chillington Hall** and **Moseley Old Hall**, were highlighted as having **poor accessibility** as they can only really be easily accessed by car. This is, however an unavoidable issue due to their remote rural location and lack of a convenient public transport service.

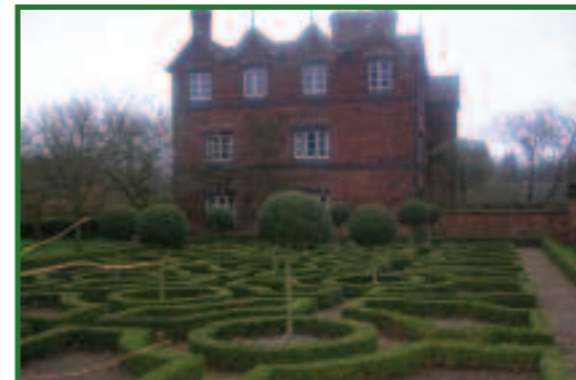
Moseley Old Hall, Fordhouses

noise, such as has been implemented at **Moseley Old Hall** to stem the noise from the M6.
